Jaytech, Inc. E-Newsletter

November 2005

White Rust: A Common Concern

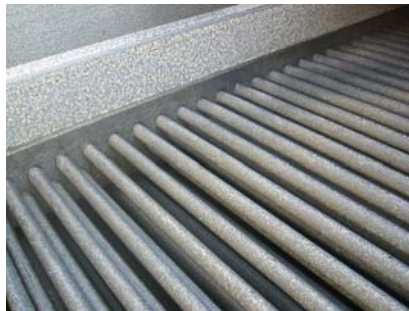
Although white rust is a type of corrosion, it is generally discovered when the galvanized cooling tower surfaces develop a white, waxy, inconsistent camouflage type pattern of zinc oxide on water contacting surfaces. It is often initially thought to be scale.

(White Rust – camouflage look)

It is the thickness of the galvanizing and the stable oxides that form on the zinc's surface that determine the durability of the galvanizing. Left untreated and allowed to develop, white rust will result in aggressive corrosion of the underlying steel and a notably early replacement of the condenser.

The standard treatment for white rust until recently has been the use of sulfamic acid to remove the deposits and then passivation of the system with a concentration of polyphosphate. Within the past year, Jaytech has developed an effective single product white rust remover and passivator for systems already affected by white rust. This is a dynamic non-acid product that can be fed with our line of other solid water treatment products. This product is also available in liquid form.

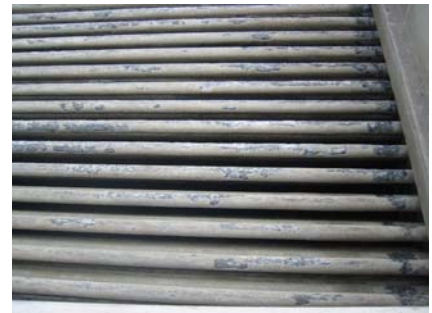
(Calcium carbonate scale)

“Jaytech Tip-1” If you are wondering if you have white rust in your new cooling tower, visually inspect any stainless steel components for deposition. If the deposits are on the stainless, you have scale since white rust only affects galvanized steel.
